GROUP Electrical	MODEL All Models
	NUMBER PS399	DATE September 2015

SUBJECT: AFTERMARKET EQUIPMENT CAUSING CAN CODES AND/OR IMPROPER OPERATION

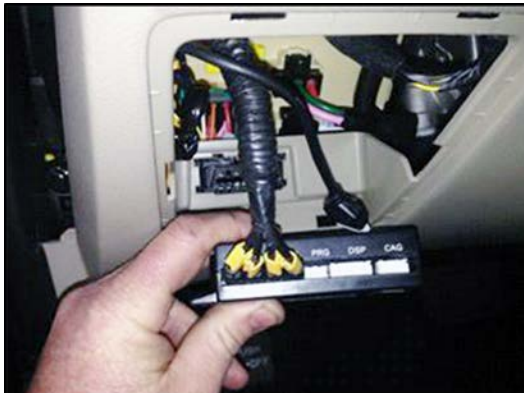
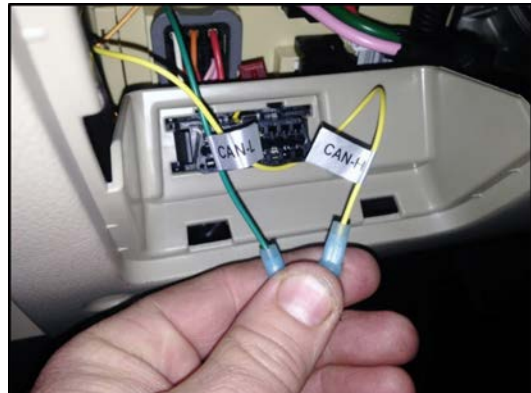
NOTE: Examples of aftermarket equipment may include: non-Kia Alarm systems, starter interrupt systems, lighting systems, cellphone chargers, parking assist systems, radar detectors, CB/HAM equipment, LoJack[®] Modules or similar tracking devices (see Pg. 2), A/V headrests, rear entertainment systems or other equipment. In the example shown below, an aftermarket parking assist module and wires spliced into the CAN system created multiple CAN codes.

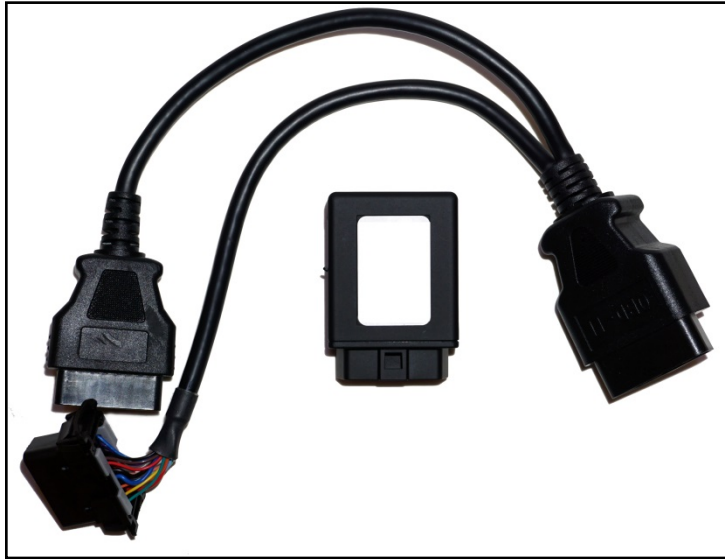
Example of a tracking device which was permanently installed / attached to the DLC port and caused various drivability issues.
